FMWR-IUCN-NCF KOMADUGU YOBE BASIN PROJECT 2006

WATER AUDIT

Komadugu Yobe Basin

Final Report

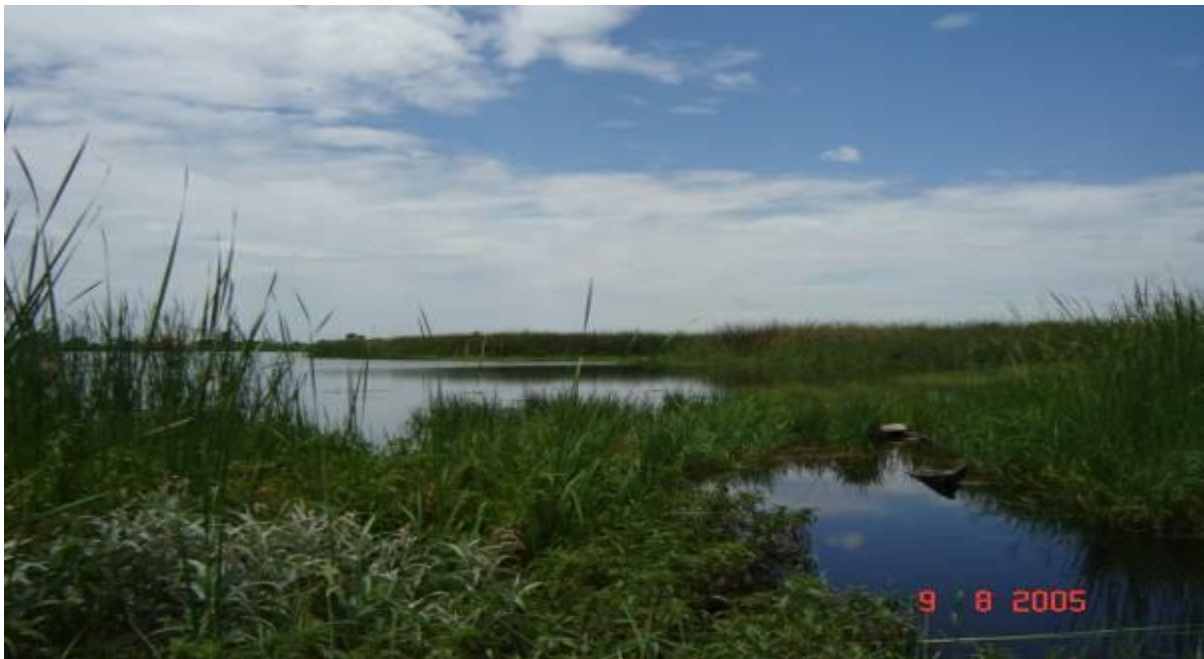
Plate 1: *Typha* infested area in Nguru Wetland

- iv) **The invasion of aquatic weeds, notably *Typha domingensis***, in the Hadejia sub-basin (see Plate 1), the consequences of which include:
- Macrophyte and silt blockages in the HNW preventing the Hadejia River from contributing to the Yobe River
 - Hindrances in the use of surface water bodies from fishing and navigation
 - The creation of a favourable environment for the multiplication of vectors of waterborne diseases
 - A reduction in biodiversity

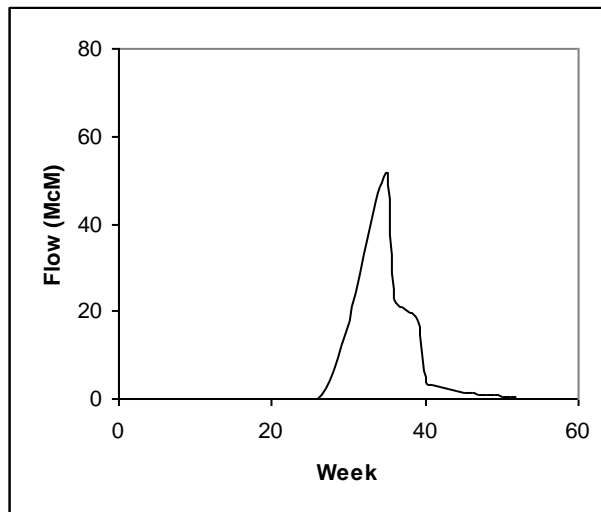
(a) Tiga Reservoir

(b) Challawa Gorge Reservoir

Figure 6.3: Mean Inflow to Tiga and Challawa Gorge Reservoirs

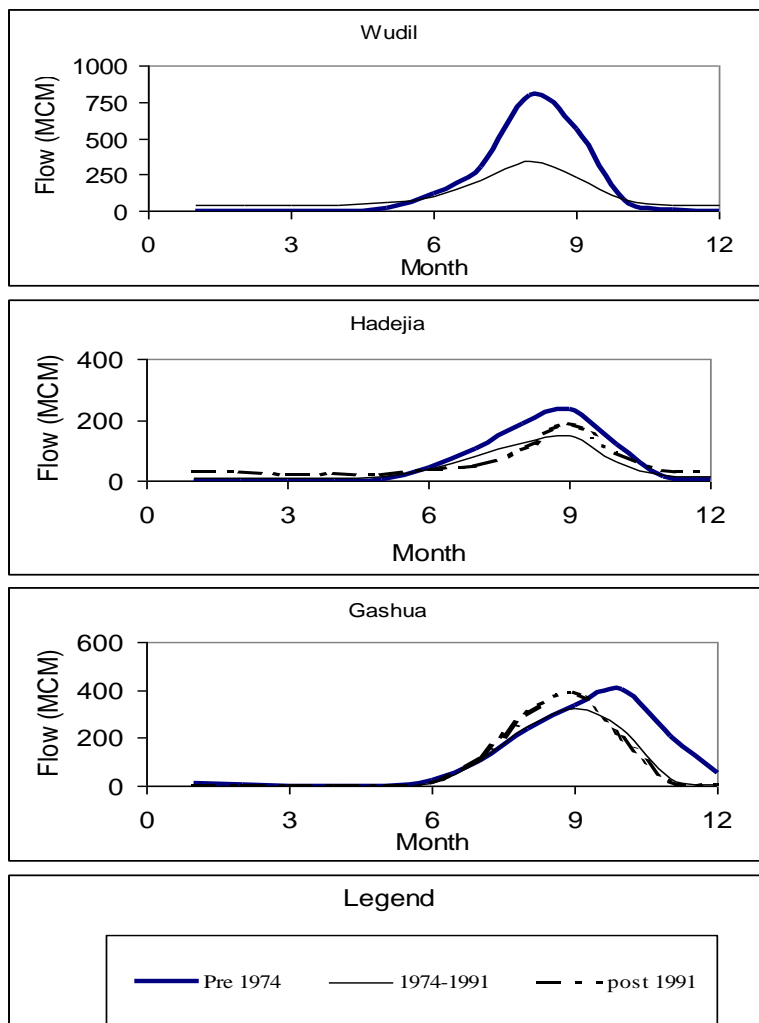
Figure 6.5: Flow along the KYB River System

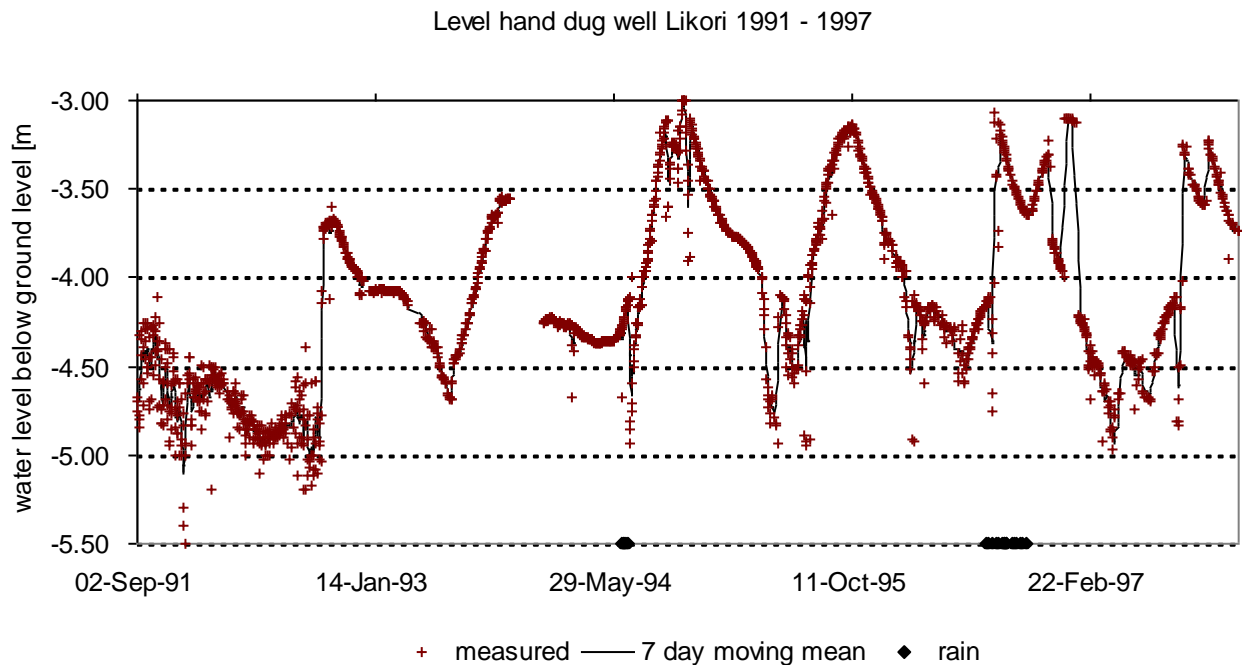
Figure 6.9: Water Levels in hand-dug wells

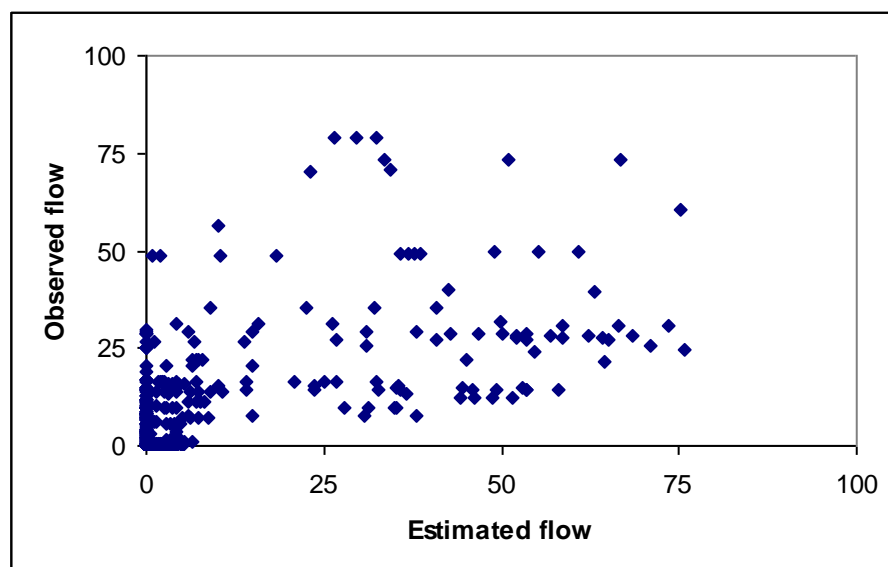
(a) Observed and estimated inflow to Challawa Gorge Reservoir

(b) Scatter diagram of observed versus estimated

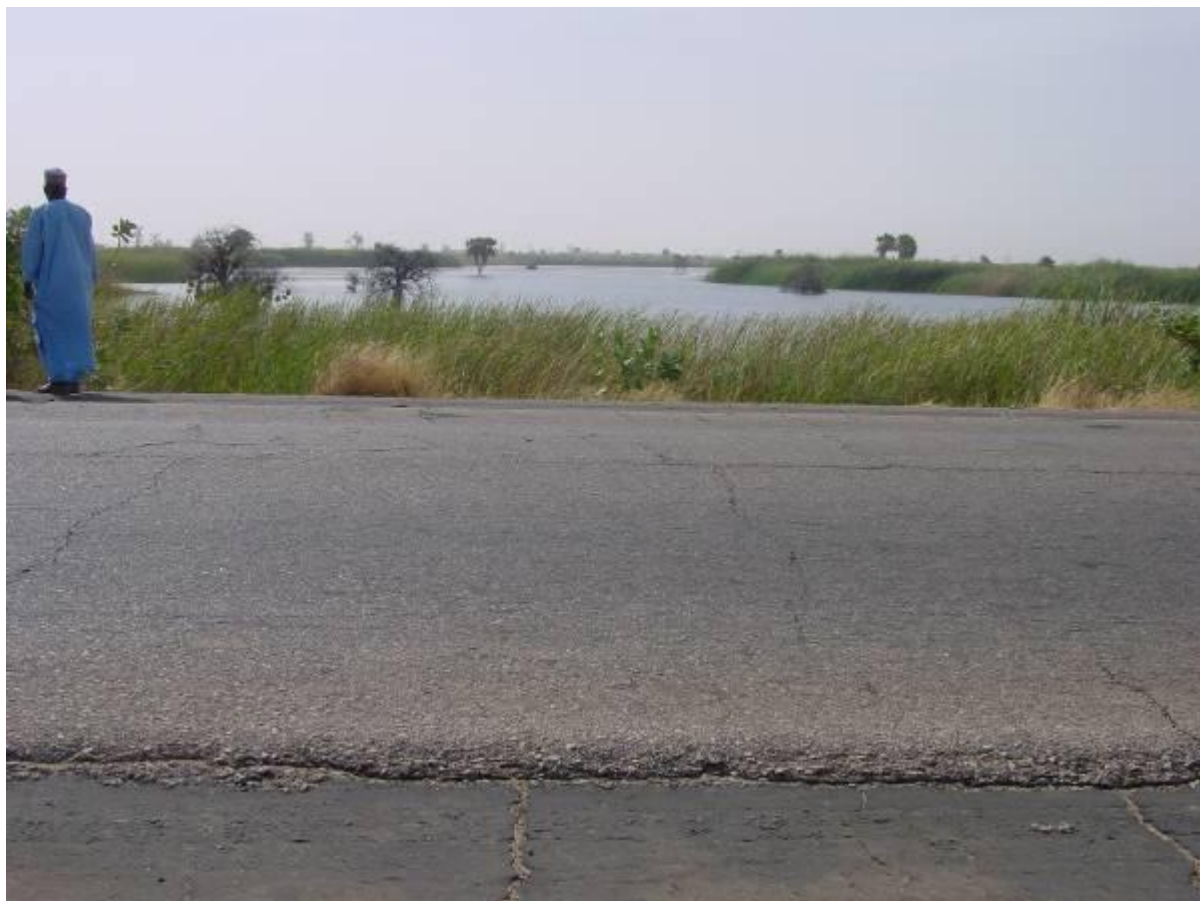
Plate 3: Siltation and *Typha* Invasion of Ruwan Kanya Reservoir

- (c) *Operation and Maintenance:* The operation and maintenance manual should be updated after all interventions are implemented. What is urgently needed is reservoir release rules.

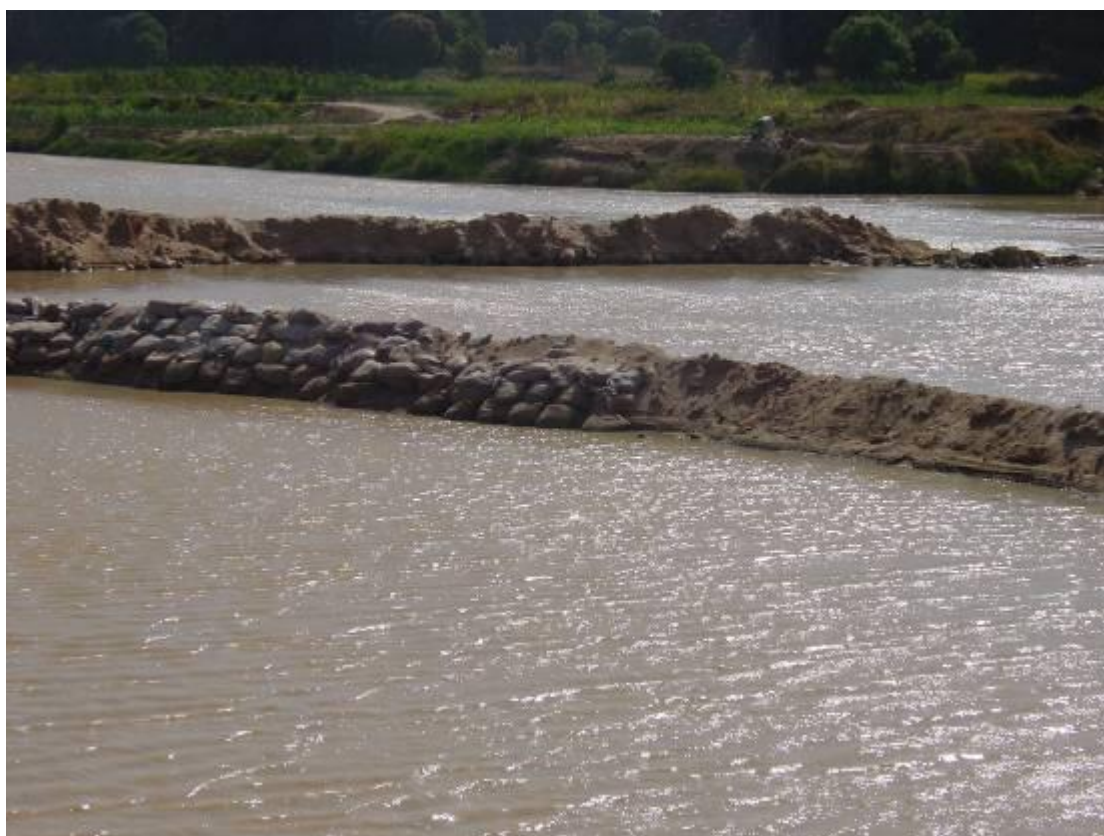
Plate 4: Diversion Structure for KCWS Intake No. 11

The benefits of these simple interventions to KCWS and to the performance of the two upstream dams shall be tremendous.

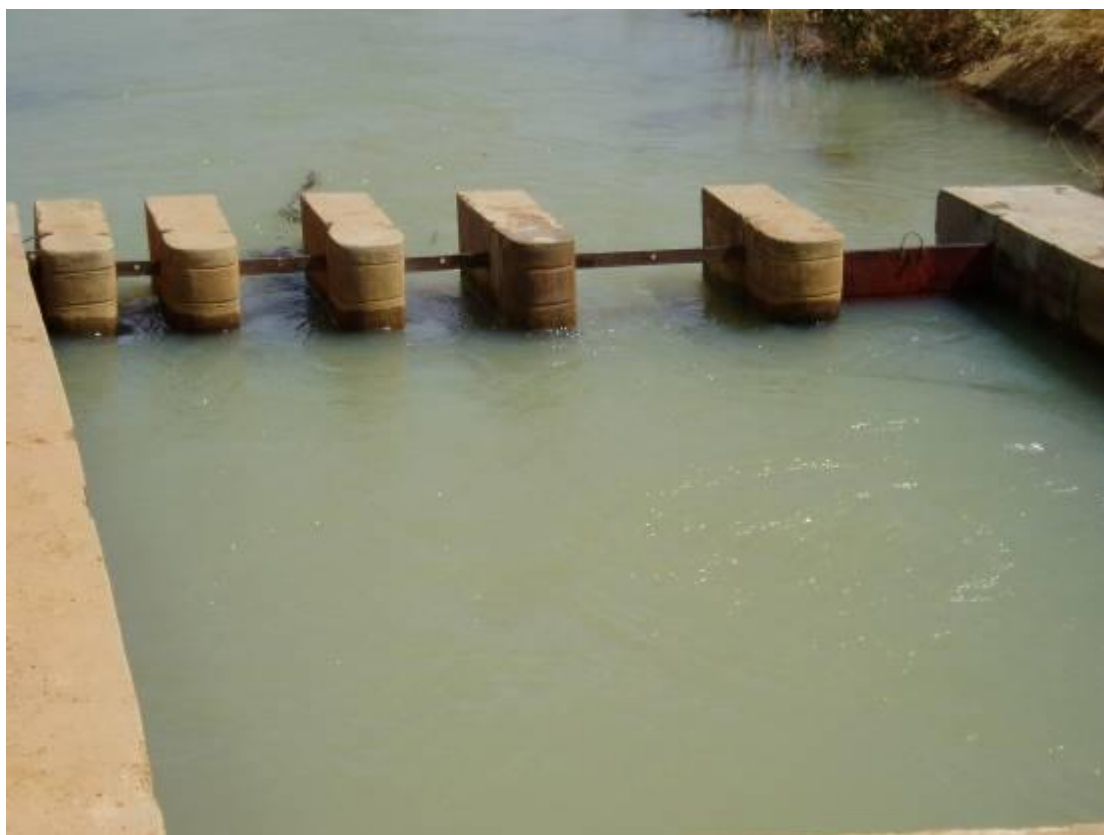
Plate 5: Kadawa Sector Turnout with missing metal shutters

The irrigated area is served by a total of nine night storage reservoirs for day time irrigation only. The main and branch canals are concrete lined, generally with precast concrete slabs. The infrastructures of the irrigation project are in need of rehabilitation. The now defunct PTF gave the scheme a partial rehabilitation. But what the project needs is a complete overhaul of the infrastructure side by side with an overhaul of the management and Water Users Association.

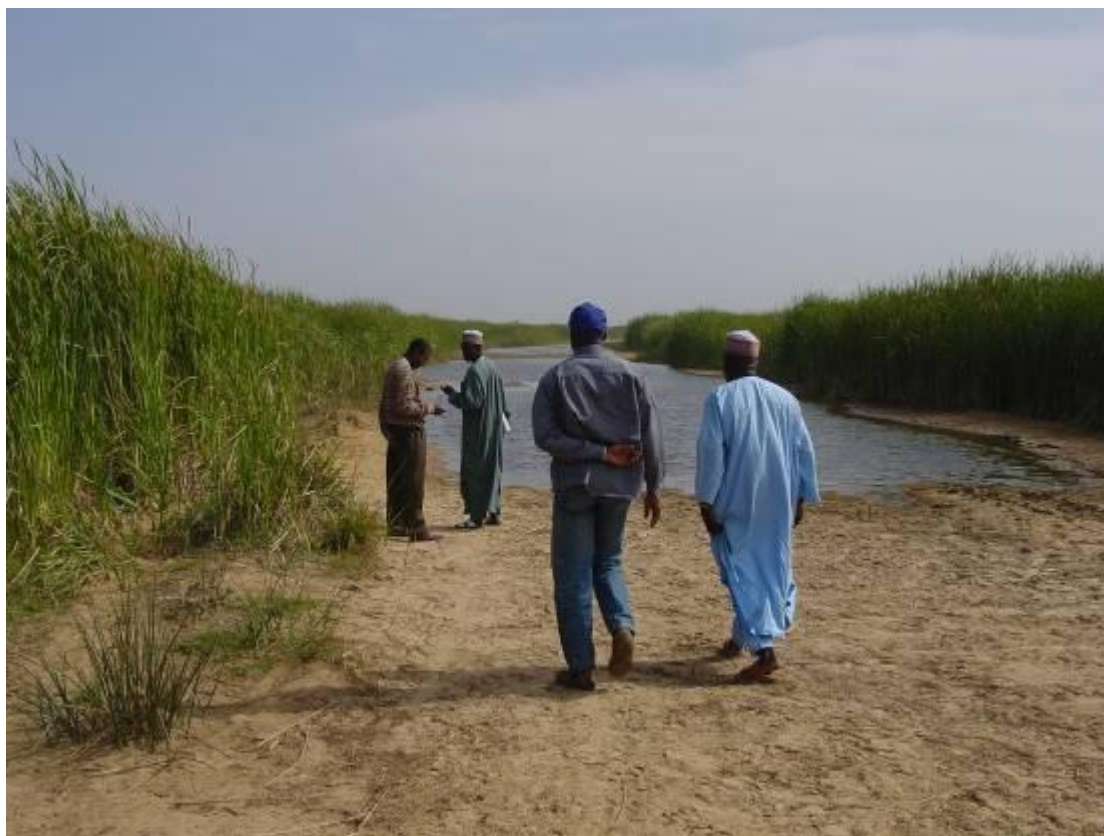
Plate 6: Blockage of Water Course resulting in flooding of Hadejia-Nguru Road

There have also been some regime changes to the river pattern in the wetlands area, with the three main river bifurcation of Marma, Burum Gana and Hadejia River tending to favour their northern oriented channels, thereby reducing flows in their eastern oriented channels.
